Manhole Inspection Summary

Manhole # S37KK_016MH

Location Address: **814 NORTH AVE**

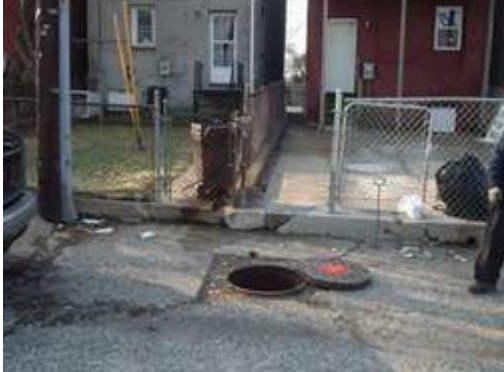
Location View

One inch above grade.

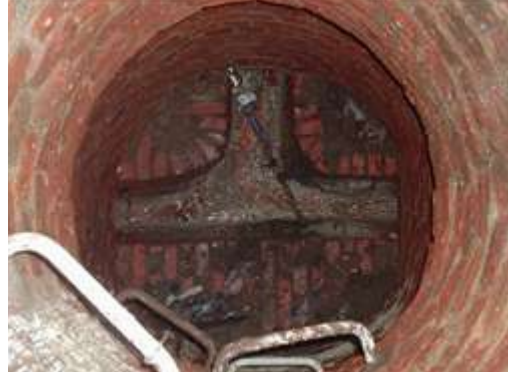
Top View

Corroded steps. Evidence of surcharge - Bench debris. Channel debris.

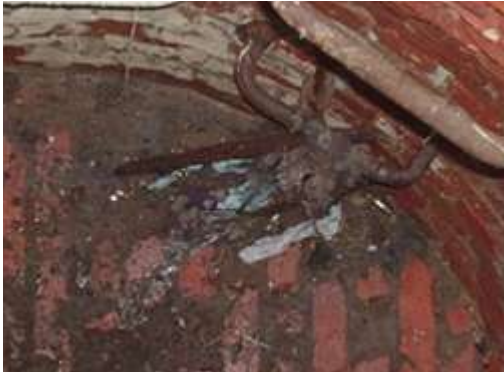
Defect

Corroded steps. Evidence of surcharge - Bench debris.

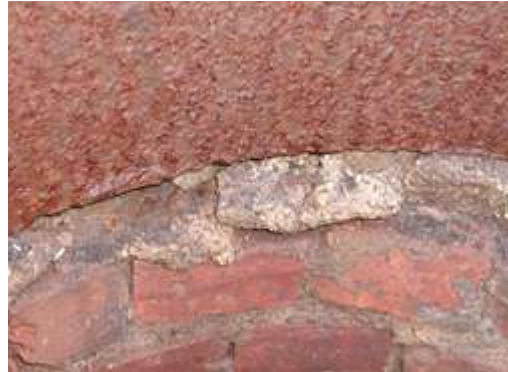
Defect

Frame leaks. Adjustment deterioration and infiltration.

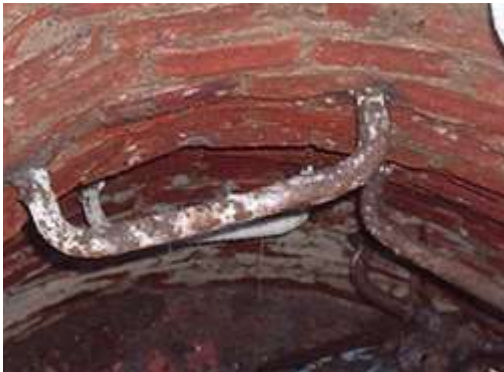
Defect

Corbel and Barrel infiltration.

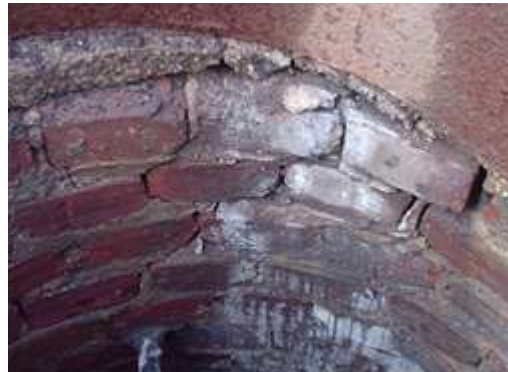
Defect

Frame leaks. Adjustment deterioration and infiltration. Corbel deterioration, loose brick, cracks and infiltration.

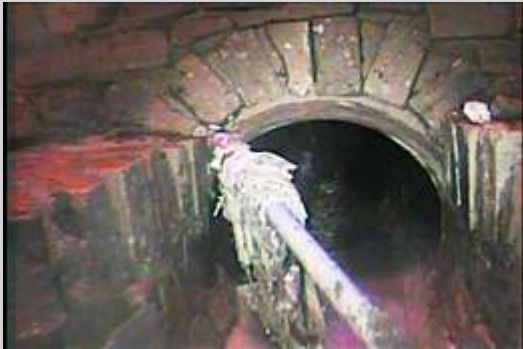
10 in. Circular Gravity Sewer Pipe Out @ 12 O'Clock

Barrel deterioration and infiltration. Channel deterioration.

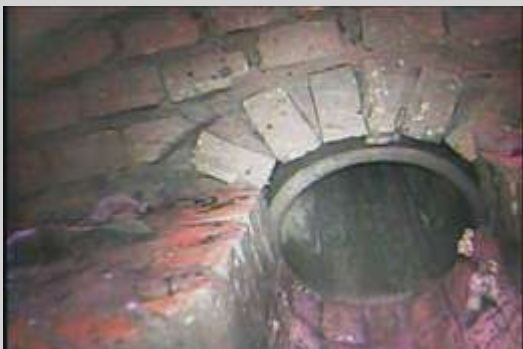
10 in. Circular Gravity Sewer Pipe In @ 3 O'Clock

Barrel infiltration and deterioration.

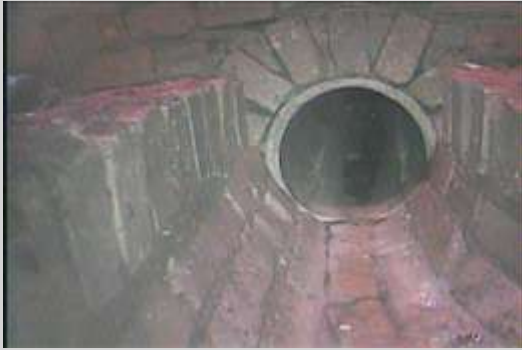
Pipe In @ 9 O'Clock

Barrel infiltration and deterioration. Channel deterioration.
